TRI-COUNTY AIRPORT AUTHORITY

AIRFIELD LIGHTING SYSTEM, SIGNAGE AND AIRPORT EQUIPMENT ASSESSMENT

TRI-COUNTY AIRPORT (1J0)

FINAL REPORT

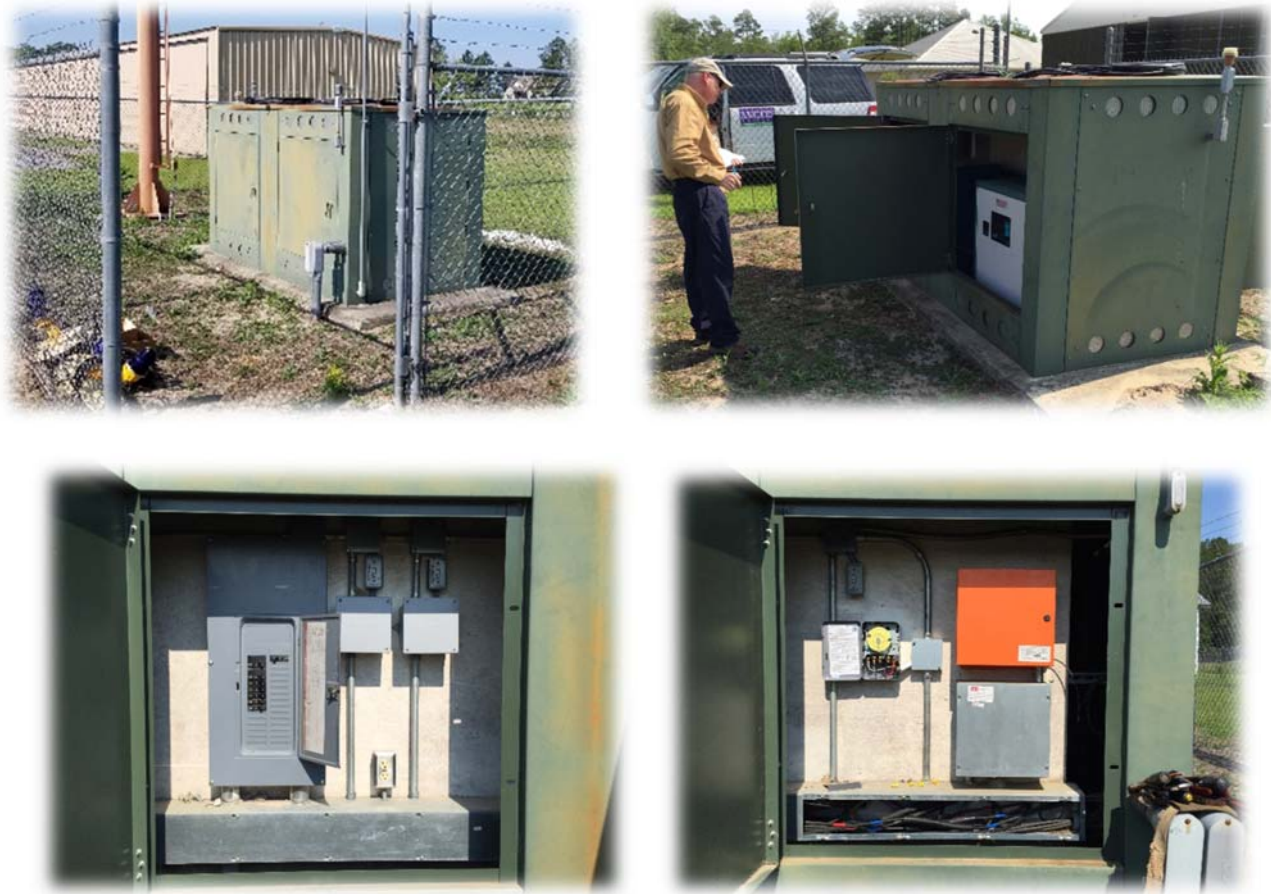
Figure 2: Airfield Lighting Enclosure (AFL Vault)

The existing AFL enclosure structure is showing various signs of deterioration. For example, there is indication of water intrusion in at least two locations and the exterior doors do not seal well. There are open vents in the top and bottom of the enclosure. The enclosure rests on a concrete pad. The enclosure should have a ground ring installed around the perimeter of the pad and have all components bonded and grounded to the ground ring. In addition to the above, the “DANGER – HIGH VOLTAGE” signs are missing on the double doors entering the electric enclosure.

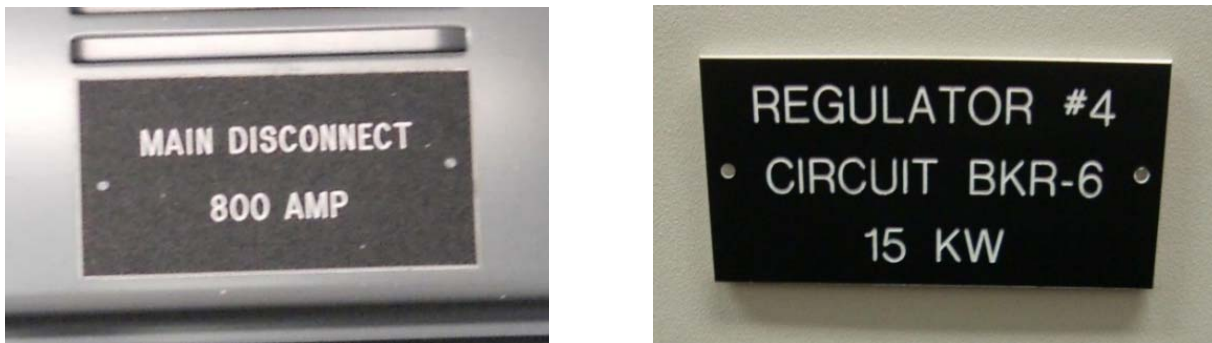
Figure 3: Typical Phenolic Nameplates on Main Disconnect and Regulator

For example, in **Figure 3**, the nameplate calls out "MAIN DISCONNECT." It is unclear if this is indicating the "normal power" or "standby power", etc. Similarly, the CCR nameplate does not indicate the source of CCR control power. See **Figure 4** for an example of a nameplate providing the proper information.

It is important that nameplates adequately describe the function of the particular equipment involved. Nameplates for panelboards and other equipment should include the panel/equipment designation, panel name, source(s) of power & voltage, and phase of the supply. For example, "Equip YY, Panel A, fed from Panel XYZ, 480/277V, 3-phase, four-wire." Consistency is key to the effectiveness of nameplates. The unique name, number, power source(s)/phase number, voltage level, and any additional pertinent information about each piece of equipment should be included on the nameplate that is referencing the respective equipment.

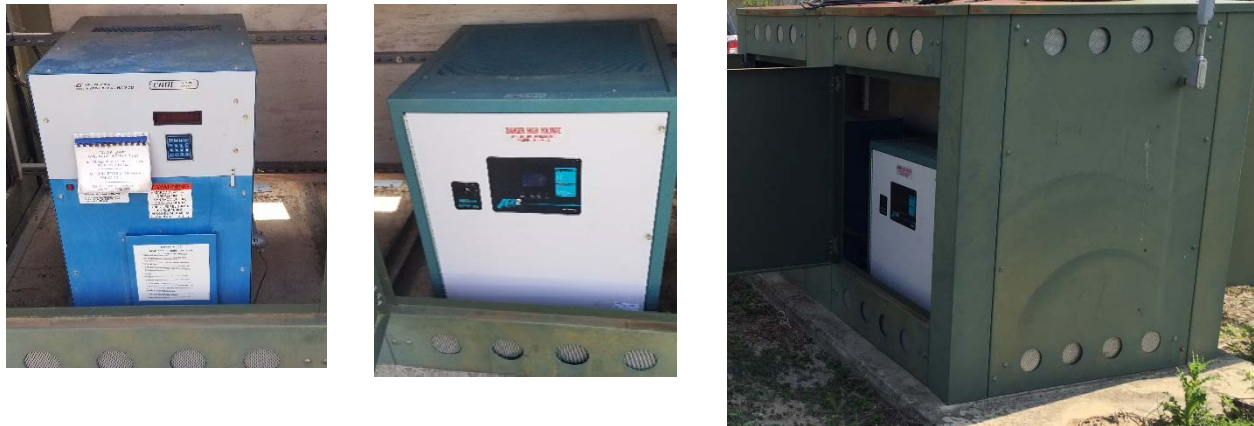
Figure 6: Existing Constant Current Regulators and Vault Enclosure

Both of the CCRs have a 6.6-ampere output and are sizes 7.5 kW and 15 kW. Both CCRs have three (3) brightness steps (see **Figure 6**).

The existing enclosure is not equipped with heating and air conditioning equipment to maintain the internal temperature within acceptable limits.

Parts for these older CCRs are expected to become more and more difficult to obtain. Lack of spare parts will shorten the useful life of these older CCRs. Therefore, it is recommended to replace the CCRs. A single wholesale replacement is ideal, resulting in a commonality of units and parts; however, if funding restraints are of concern, a phased approach may be considered, replacing units in sequence.

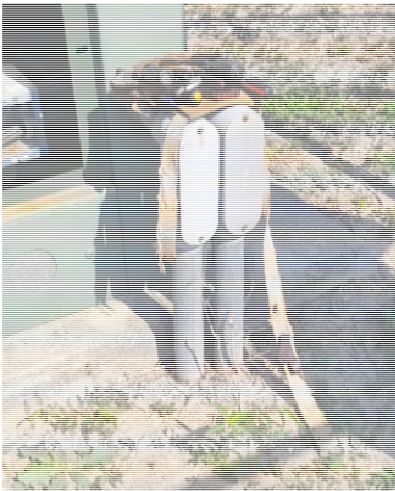
Figure 7: LB fittings

The interface with the field circuits occurs on the east wall of the enclosure through two LB fittings penetrating the enclosure wall as in **Figure 7**. L-823 connector kits are located in the wire-way to allow disconnecting and shorting of the CCR/airfield lighting circuits for troubleshooting purposes as in **Figure 8**. No SCO-1 cut outs are installed to safely disconnect the circuit from the airfield or short the regulator for testing as in **Figure 9**.

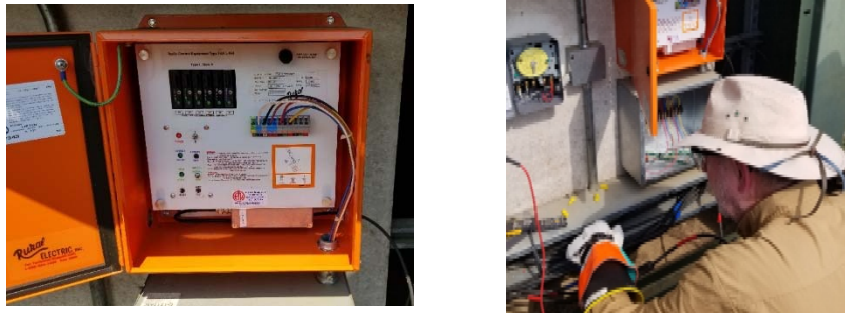
Figure 10: Pilot Control Lighting L-854 Radio Decoder

The L-854 Pilot Radio controls the airfield lighting. The airfield lighting is activated by the aircraft radio, via the PCL. It is intended that three clicks on the microphone turn the lights on to the B10 step; five clicks turn the airfield lighting on to the B30 step; and seven clicks turn the airfield lighting on to the B100 step (full intensity). The PCL was tested during the sight visit and was malfunctioning while stepping through the 3,5, and 7 mike clicks.

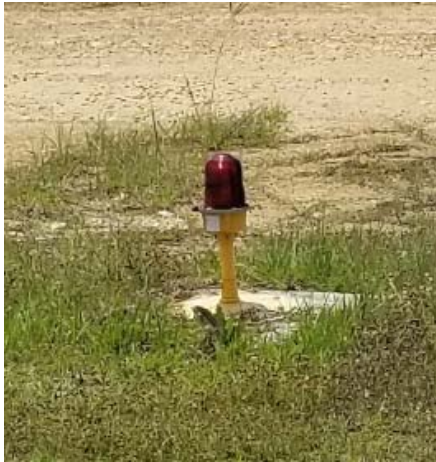
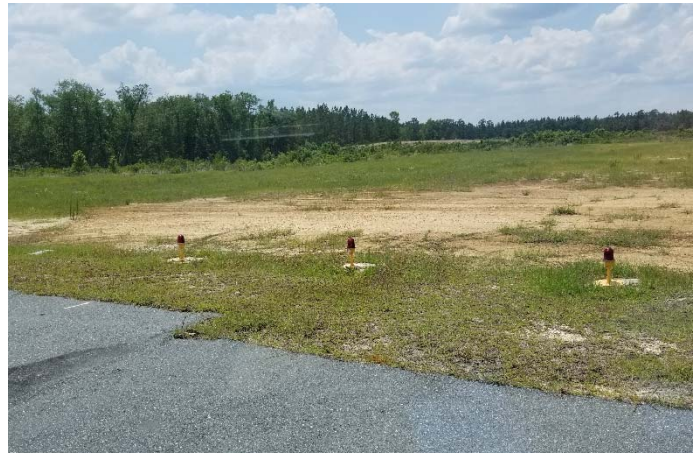
Figure 11: Runway Threshold Lighting

- The Runway 1-19 threshold light configuration does not conform with current Federal Aviation Administration (FAA) standards and must be addressed;
- The Airfield signage is generally in poor condition;

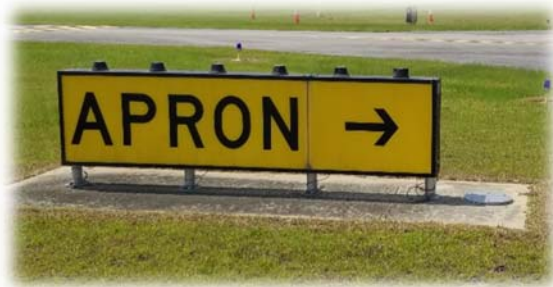
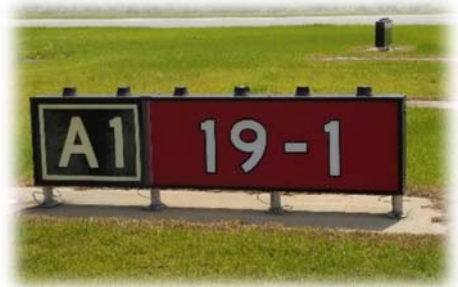
Figure 12: Taxiway Directional Sign and Mandatory Hold Sign

Airfield signage units are Size 2, Style 2&3 units and are generally in fair condition with some signs requiring faded or damaged panels to be replaced. The signs on the airfield are older, ADB incandescent L-858 Signature Series as shown in the photos below (see **Figure 12**). The existing signs were manufactured and installed in the 2015 time period. The ADB signs can be recognized by the tapered lamp housing screw tops.

The cost of light-emitting diode (LED) signs has decreased considerably in the last few years. Currently, the cost of a new LED sign and a new quartz incandescent sign are virtually the same per module. **AVCON** recommends replacing the signs with new LED models. The longer life of the LED units, resulting in lower maintenance costs and reduced energy usage, makes the LED signs a desirable and economical choice.

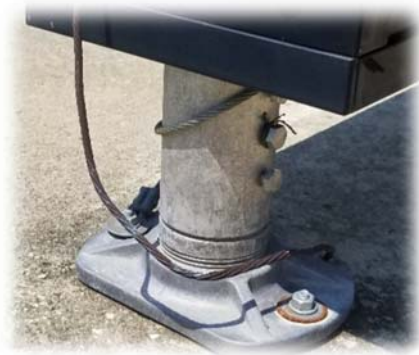
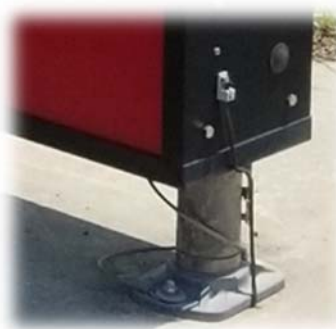
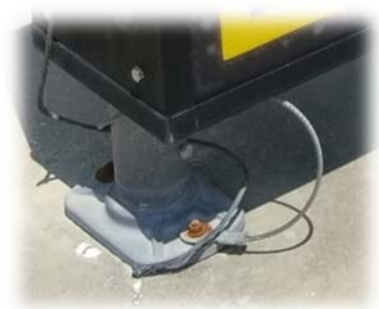
Figure 13: Sign Bonding to Ground Rod

Most of the signs have a ground conductor attached to the sign and going under the leg of the sign. This ground conductor should connect to a ground rod. At the time of the visit this could not be determined. The grounding of each sign should be inspected and replaced as required with the ground conductor terminating at a ground rod.

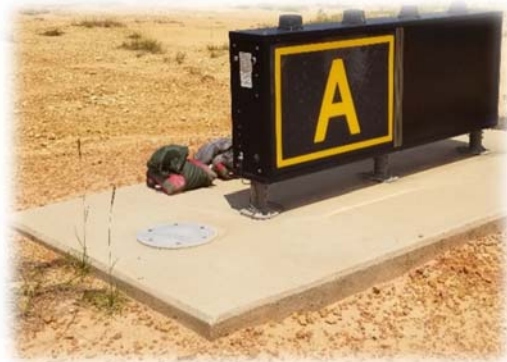
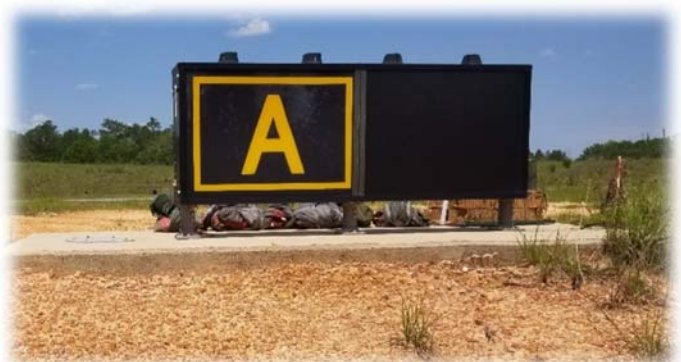
Figure 14: Sign Grade not in accordance with FAA EB 79

The distance from grade to the frangible point of the fixture needs to be 3" or less per FAA Engineering Brief 79. Grading around these fixtures and sodding to restore the grade can correct this condition (see **Figure 14**).

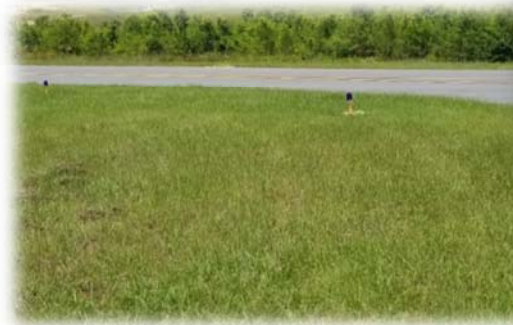
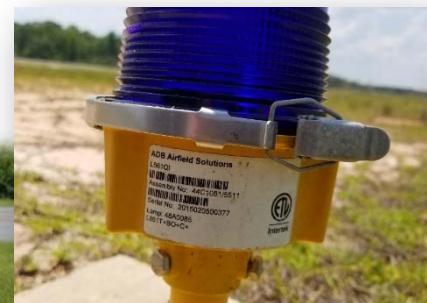
Figure 15: Taxiway Edge Lighting

The taxiways west of Runway 1-19 utilize incandescent fixtures and are generally in fair to poor condition. The quartz incandescent L-861T taxiway edge lights, L-824 cables, L-823 connectors and L-830 isolation transformers are all recommended for replacement with LED fixtures.

There are several areas of the airfield having inconsistent lighting patterns that are not in accordance with FAA criteria for taxiway edge lighting per FAA AC 150/5340-30. These areas are mainly at the “T” intersections of Taxiway A and the connectors to the runway. The far side of these connectors, on the single edge of the taxiway, do not have adequate lighting along the edge. This condition can be corrected by installing additional lighting along the edge of pavement in these areas. In addition, the edge lighting in some areas exceed the maximum height above the surrounding grade. The distance from grade to the frangible point of the fixture needs to be 3” or less per FAA Engineering Brief 79. Grading around these fixtures and sodding to retain the grade can correct this condition (see **Figure 15**).

The cost of LED taxiway light fixtures has decreased considerably in the last few years. Currently, the cost of a new LED and a new quartz fixture are virtually the same. **AVCON** recommends replacing the fixtures with new LED models. The longer life of the LED units, resulting in lower maintenance costs and reduced energy usage, makes the LED fixtures a desirable and economical choice.

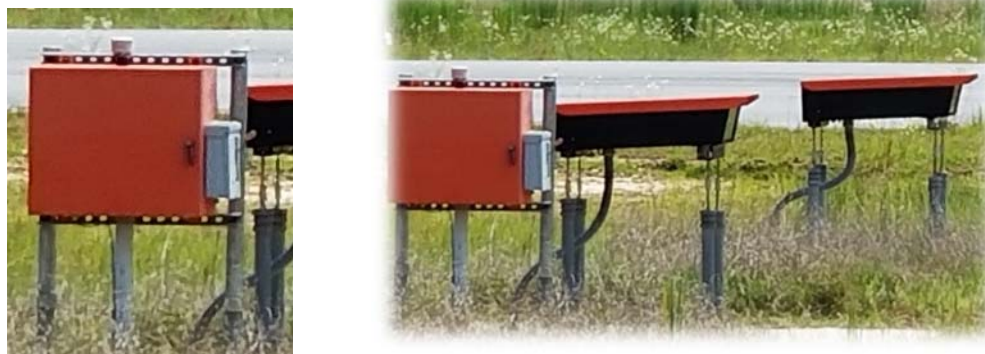
Figure 16: Runway 19 PAPI

- Overall, the airfield lighting home run cables generally have a low insulation resistance value and need replacement;
- Runway 1, and Runway 19 Precision Approach Path Indicators (PAPIs) need replacement;

Construction of a new vault to add additional constant current regulators (CCRs) for the addition of a TCAA-owned and maintained PAPIs on Runways 1 and 19 would create space for new dedicated PAPI CCRs. Refer to Chapter 5, Section G for details concerning NEC required working space in the vicinity of airfield lighting equipment. Per recommendations made in Chapter 5, a new airfield lighting vault should be considered and included in the Airport’s capital improvement plan.

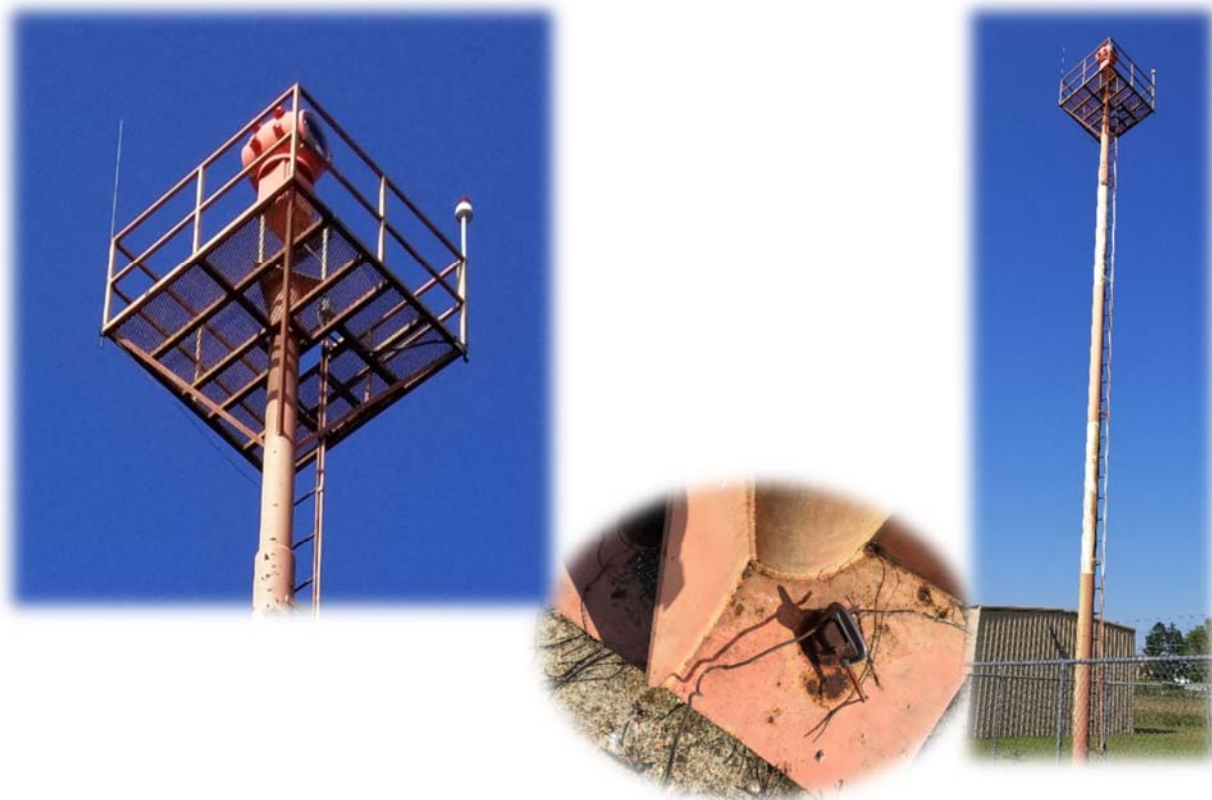
Figure 17: Airport Rotating Beacon and Tower

The Airfield Beacon bonding and grounding is in poor condition. AVCON suggests installing a ground loop around the structure, installing a bonding conductor from the beacon to the ground loop and replacing the lightning protection down conductor between the beacon tower and the ground loop.

Airport rotating beacons typically have an expected life of up to 20 years depending upon the impacts of environmental conditions, as well as the quality and frequency of the maintenance performed over the life of the equipment. The Airport's existing L-802A high intensity rotating beacon is estimated to be in excess of 10 years old, has been impacted by the environmental conditions, and beyond its useful life due to unavailability of spare parts. (see **Figure 17**). It is ultimately recommended to include a complete airport rotating beacon replacement at the end of the capital improvement budget.

Short-term basic service/repair efforts may be completed to keep the existing beacon in working order until funding is available for a complete replacement. These recommended efforts include replacing the existing bulb with a longer-life, metal halide lamp; inspection/repair of the existing fall protection system; re-painting the existing beacon and pole; and various grounding improvements. Currently, the existing beacon pole has a strike termination device installed, but no visible grounding electrode. It is recommended to have a local grounding electrode installed and bonded to the beacon pole and the circuit equipment grounding conductor. It is further recommended that the lightning protection system on the beacon be inspected for compliance with NFPA 780.

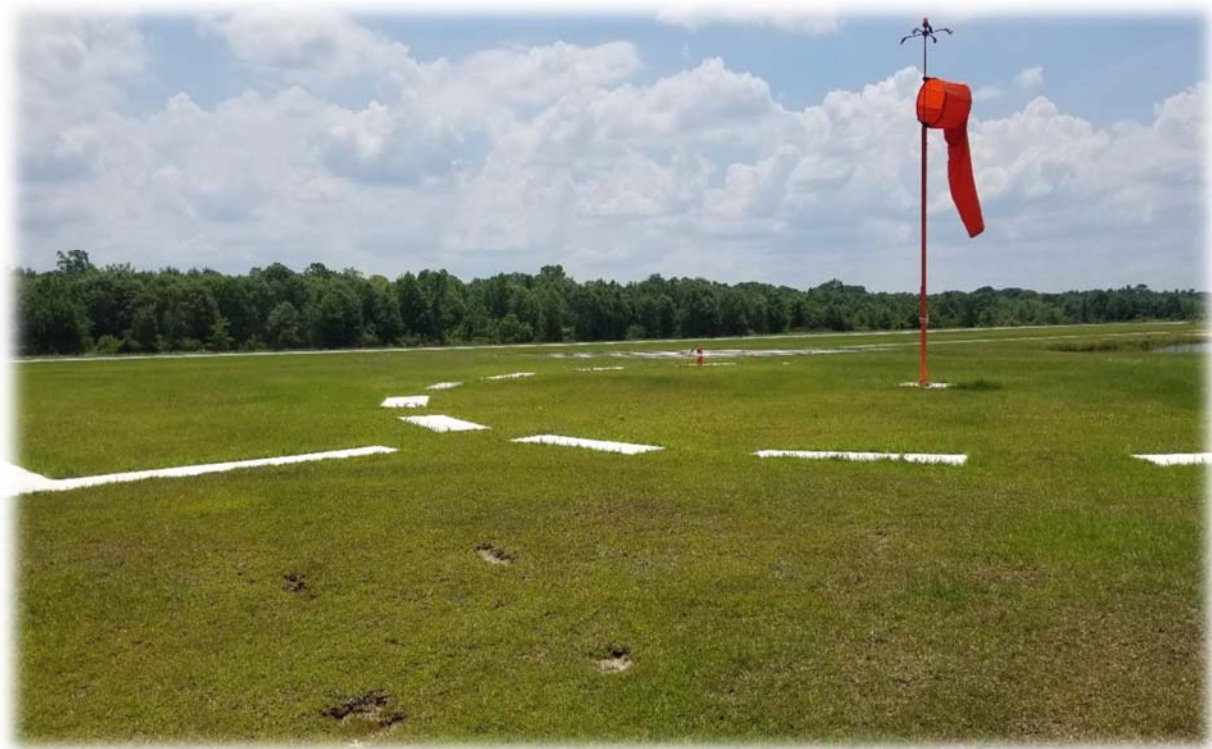
Figure 18: Existing L-807 Main Wind Cone with Segmented Circle (Centerfield)

The Airport's centerfield wind cone is shown in **Figure 18**. This wind cone is an L-807 halogen, externally lighted wind cone with a 12-foot sock and Segmented Circle with landing pattern indicators. The wind cone is in close proximity to the Fuel Farm and Helipad. AVCON recommends replacement of the existing windcone with an internally lighted L-807 primary windcone. The electrical load from an LED unit will be significantly lower and the unit would require fewer bulb changes as the average life of a LED fixture is approximately 50,000 hours.
