TRI-COUNTY AIRPORT AUTHORITY

AIRFIELD LIGHTING SYSTEM, SIGNAGE AND AIRPORT EQUIPMENT ASSESSMENT

TRI-COUNTY AIRPORT (1J0)

FINAL REPORT

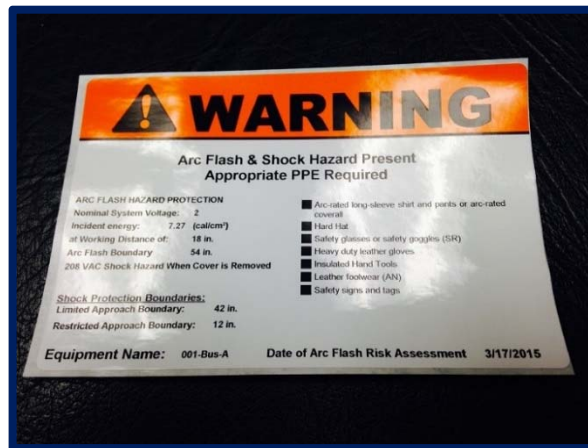
Figure 5: Generic Arc-Flash label

An arc-flash hazard assessment is an effective means of identifying electrical hazards in the workplace. More specifically, the Occupational Safety and Health Administration (OSHA) requires that an assessment be performed to: “determine if hazards are present, or are likely to be present, which necessitate the use of personal protective equipment (PPE).” There are no records of an Arc-Flash Hazard Assessment being performed in the past at 1JO. A Short Circuit/Coordination/Arc-Flash Study is highly recommended for the AFL vault electrical system. See **Figure 5** for a generic Arc-Flash label.

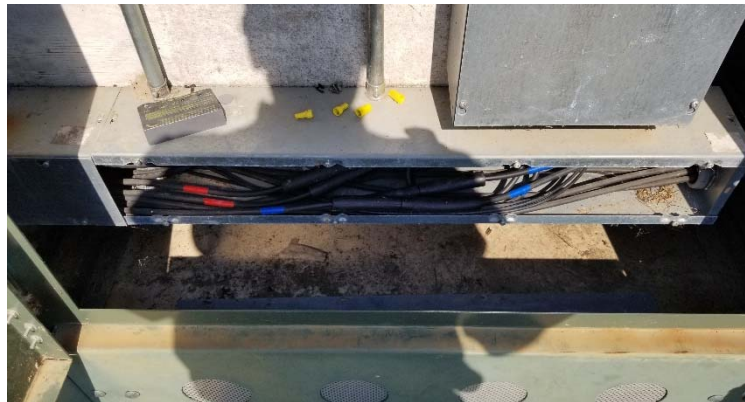
Figure 8: L-824 CCR Wireway

The interface with the field circuits occurs on the east wall of the enclosure through two LB fittings penetrating the enclosure wall as in **Figure 7**. L-823 connector kits are located in the wire-way to allow disconnecting and shorting of the CCR/airfield lighting circuits for troubleshooting purposes as in **Figure 8**. No SCO-1 cut outs are installed to safely disconnect the circuit from the airfield or short the regulator for testing as in **Figure 9**.
